# Earthquake in Pakistan

## **An Assessment of Environmental Risks and Needs**

**Based on IUCN Field Missions to NWFP and AJK**  
November 19–26 and December 4–7, 2005

January 16, 2006

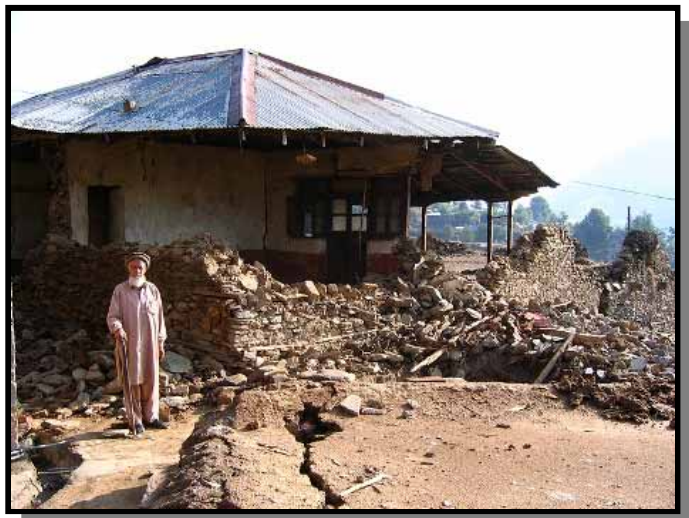
Huge losses in life and property were reported in the areas of NWFP which were visited. Landslides have occurred at many locations in the hilly areas. Most of these slides had not stabilized at the time the mission was fielded, as was especially observed in *Allai*, where the soil was still unsettled due to continued tremors.

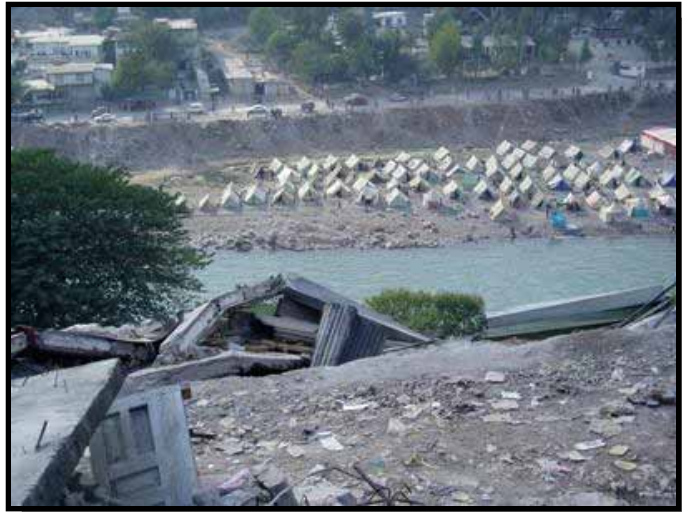
**Flash Floods:** Landslides caused by the earthquake have temporarily blocked several rivers. This kind of river blockage risks causing flash floods once the dam breaches. As more landslides are expected, the risk of flash floods is not over. Therefore people should avoid to camp or stay close to the river beds.

In the *Muzaffarabad* district, en-route to *Bagh*, in the *Hattian Bala/Chakaar* area, a massive landslide

has blocked the river of a side valley of the *Jehlum* River. The dam created by the landslide may be as high as 150 to 250 meters. Behind this dam a lake is slowly being formed, inundating the communities residing there. It will take months or even years to fill this lake. However, once the lake is full, there is a risk that the dam, created out of non-consolidated landslide rubble, may breach. A landslide into the lake could create a big wave that can destabilize the dam. If the dam gives in, it could cause a catastrophic flash flood, which would sweep away communities and cities downstream, along the *Jehlum* Valley down to the plains of Punjab.

The risk of this dam is such that it has to be assessed by most qualified experts. Large scale engineering works to reduce the maximum level of the lake, as much as possible, will probably have to be undertaken.

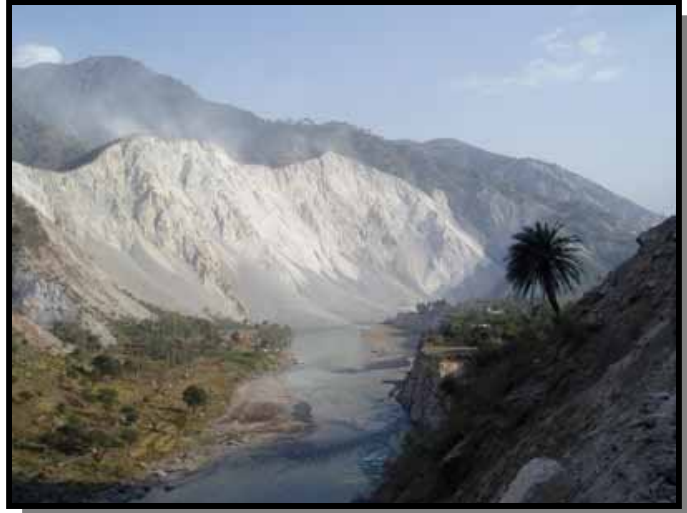
**Silt Load in rivers:** The rivers in the affected areas have received large volumes of sand, soil and stones from the landslides that occurred as an immediate consequence of the EQ. This has significantly raised the silt load in these water bodies, which will be transported downstream. This may not be apparent at the moment, and the material deposited in the water bodies may appear to have settled at present, mainly due to the low flow in the rivers.

However, as the volume of water in the rivers increases after rains, this silt may dislodge and be carried downstream. This will increase the rate of siltation of the *Mangla* reservoir, located near the town of *Jehlum* in Punjab further downstream on the River *Jehlum*.

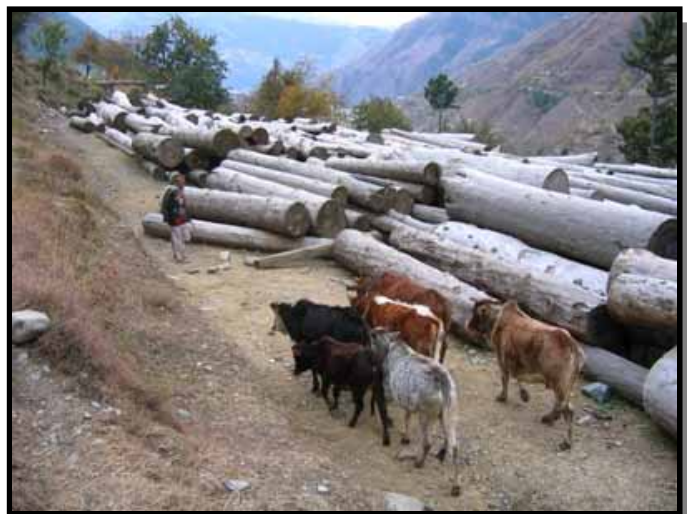
**Damages to Trees and Forests:** In the core area of the earthquake, standing forests on steep slopes were destroyed by landslides. Furthermore, many trees were damaged by rock falls. The earth shaking during the EQ was such that some trees simply truncated about two meters above the ground. The inner structure of many trees may have been damaged which would affect their use in future.

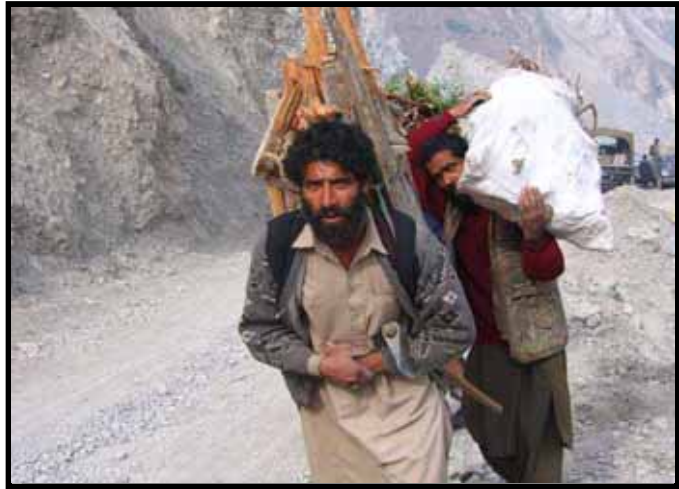
standing forests may be felled for fuel wood and timber needs. There is a risk that if alternate energy sources are not identified, or alternate (less timber intensive) construction methods are not introduced, people will resort to cutting trees to rebuild their houses. At places it was noticed that people have started to remove timber and other construction material from debris to start reconstruction of their houses. However, in some places the timber from destroyed houses is damaged and no longer good for construction. It was observed in many locations in AJK, where people had already received compensation money, that timber intensive reconstruction had begun. In the face of these factors the risk that people will cut forests is **high**. Deforestation poses an urgent and long term threat to the environment.

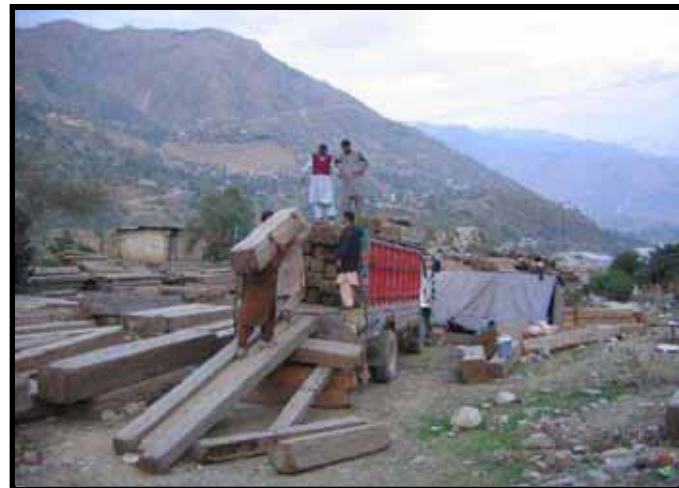
Another observation was made which also adds to the above, already high, risk. The timber stored in the affected areas is being transported out at an alarming rate for sale in high price markets in the lowlands. The Coordinating Officer in *Allai*, Col. Zakeer has placed a ban on the movement of timber out of the valley to reduce the need for cutting of trees for construction and other purposes.

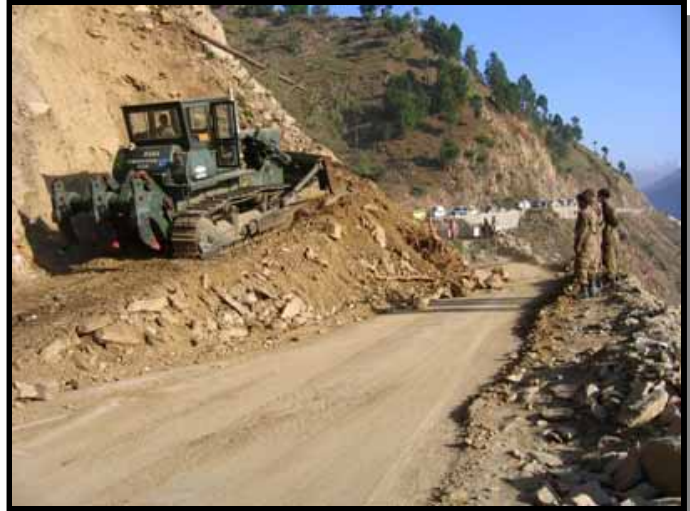
**Roads:** Due to the devastating EQ, many roads have been destroyed in the mountain areas of AJK and NWFP. The army did a great job in quickly repairing the main roads. Still, there are many link roads which have not been repaired, and it is difficult for the people living there to get the necessary relief items and material for reconstruction of their shelters and houses. The winter, with snow and rain and more landslides and mudslides, will again close many of these roads.

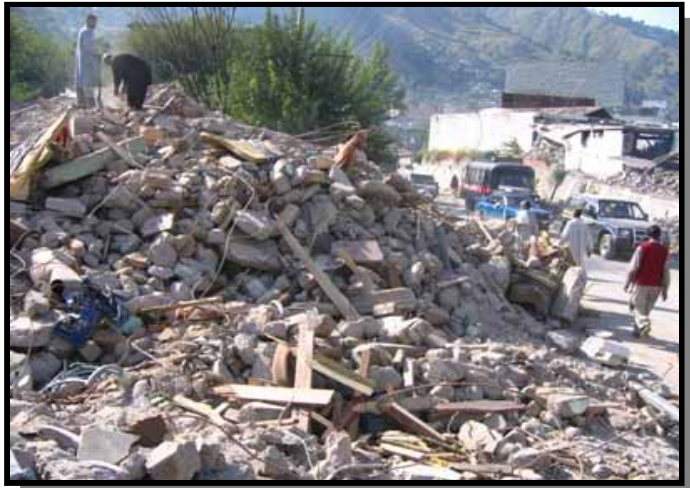
**Debris removal:** A major environmental challenge, mainly in the affected urban areas, is that of proper removal of the debris of collapsed buildings. Part of the debris need to be separated and used for reconstruction. The rest has to be removed to proper dumping sites. If the rubble is dumped anywhere without considering the topography, hydrology and drainage patterns of the area, it is likely that this would have adverse effects on the overall hydrology of the area.

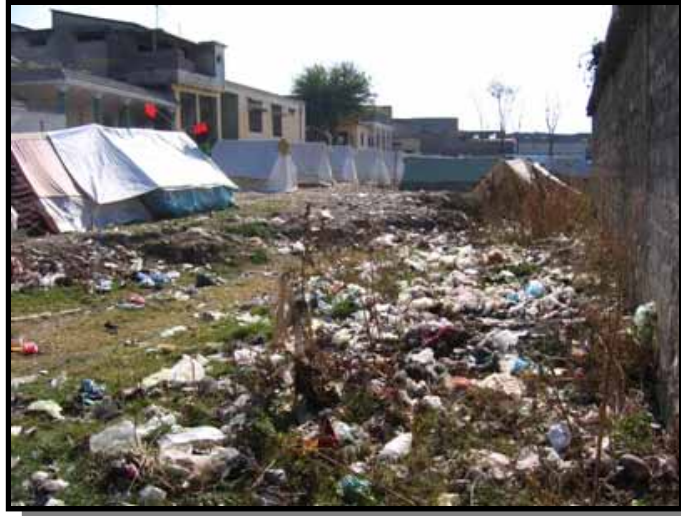
- **Waste management:** Solid and liquid waste management, was, most of the time, not adequate, even before the earthquake. The rudimentary waste management systems, where they existed, have collapsed. The relief operations have added to the amount of waste accumulated in the areas. There are three types of wastes being generated in the relief camps 1) **aid waste**, which was seen scattered all over during the first mission but had almost disappeared by the time of the second mission, 2) **domestic waste**, generated by camp operations such as kitchen waste and other related waste, and 3) **medical waste**, from field hospitals which at some camps is being managed adequately, but mostly being just mixed with domestic waste creating potential serious health hazards.

The most serious problem is the management of medical care waste. Waste management was not a priority during the first weeks of relief operations. Except in some well managed larger camp sites, waste mismanagement is rampant; if this issue is not addressed effectively, it will cause more problems and lead to diseases, even epidemics.
